**Flood Control Project Maintenance
Levee Inspections**
LMA District Cover Sheet
Spring 2017 Levee Inspection Results

Reclamation District No. 0341 Sherman Island

Spring 2017 Levee Inspection Results

| Waterway | | | Bank | Unit Miles |
|--|---|---|---|---|
| Unit No. 01 Threemile Slough | | | Right | 3.36 |

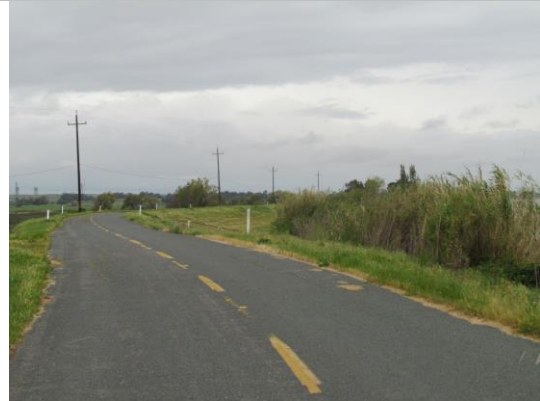
Photo 1 of 1 : SP_2017_RD0341_167_20_20170510_00047.jpg

RD 341 Looking downstream from crown roadway levee mile 0.00.

| Control the regrowth on the waterside.. | | | | | |

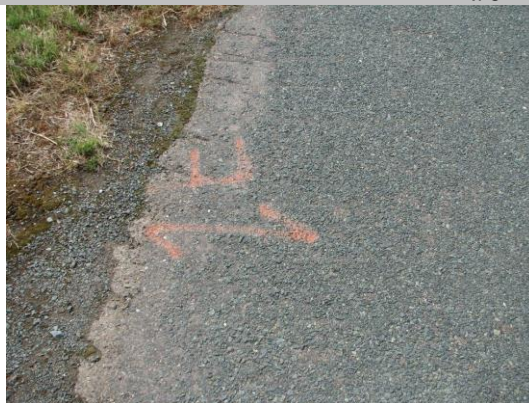
Photo 2 of 3 : UCIP_SP_2017_22064_37646.jpg

| UCIP Comments: Markers Missing. No markers found to confirm crossing is still in use--need to contact owner to determine status of crossing. | | | | | | |
| FIELD_STRUCT_DESC: 3-inch electrical conduit through the levee, 3.5 feet below the crown. Location marker on waterward shoulder--no marker found. Pole on landward side. Rock revetment on waterward slope. (Permit No. 6297-1969) | | | | | | |

Underground Service Alert (USA) markings on road shoulder.

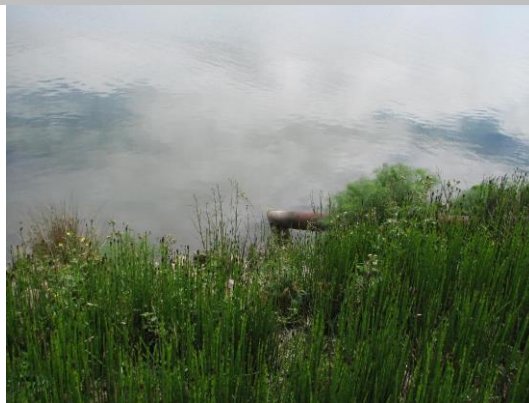
Photo 2 of 3 : UCIP_SP_2017_22068_37658.jpg

| FS_ID:22068 DS_ID:24111 EP_NO: 1477 Repair Type: Non-Urgent Crossing Status: Found UCIP Comments: Dense vegetation limits the inspector's visibility to identify signs of pipe failure (leaks) along the slopes. Recommend removing vegetation along pipe alignment to conduct proper inspection of structure and appurtenances. FIELD_STRUCT_DESC: 10-inch steel pipe through the levee, 1.8 feet below the crown. Pipe is encased in 12-inch CM condutor pipe under crown. Pump on landward side. Air vent and metal distribution box with gate on the landward side. Rock revetment on the waterward slope. (USACE-1962). This entry matches the Drainage or Irrigation Structure referenced in O&M manual (HLM 0.50). 30-feet of pipe under crown was replaced and encased in CM pipe under Permit No. 1477 (1950). FS Date: 5/5/2009 | | | | | | |

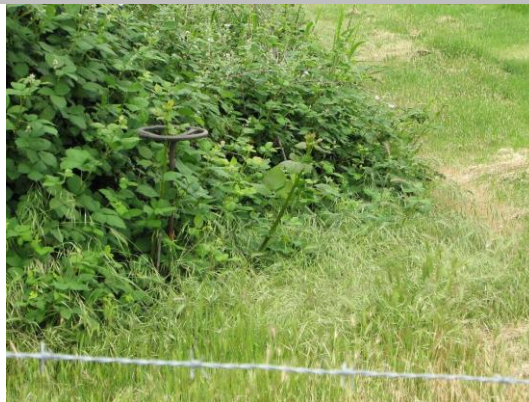
Photo 3 of 3 : UCIP_SP_2017_22070_37662.jpg

| FS_ID:22070 DS_ID:24113 EP_NO: 11095 Repair Type: Non-Urgent Crossing Status: Found UCIP Comments: Dense vegetation limits the inspector's visibility to identify signs of pipe failure (leaks) along the slope. Recommend removing vegetation along pipe alignment to conduct proper inspection of structure and appurtenances. FIELD_STRUCT_DESC: 18-inch pipe sleeved through 24-inch pipe through the levee, 4.0 feet below the crown. Air vent and monitoring well on landward side. Pipe exposed on the waterward slope. This pipe was retained under ABO No. 11095 (1975). FS Date: 5/5/2009 | | | | | | |

Gate located past the fence area near landward toe.

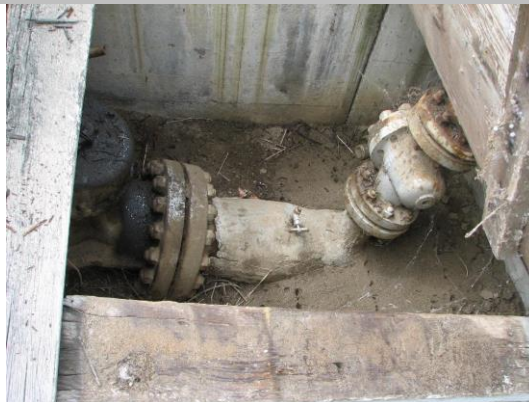
Photo 2 of 3 : UCIP_SP_2017_22074_37672.jpg

| FS_ID:22074 DS_ID:24115 EP_NO: N/A Repair Type: Non-Urgent Crossing Status: Found UCIP Comments: Need to contact owner to determine if crossing is still active and to determine last inspection date. Will need copy of letter showing crossings passed inspection. NEED photo of emergency contact information from marker. FIELD_STRUCT_DESC: 10-inch steel gas line through the levee. Valve in concrete box on the landward side. (USACE-1962). This entry matches the Drainage or Irrigation Structure referenced in O&M manual (HLM 1.42). FS Date: 5/5/2009 | | | | | |

Inside view of vault located on the landward side.

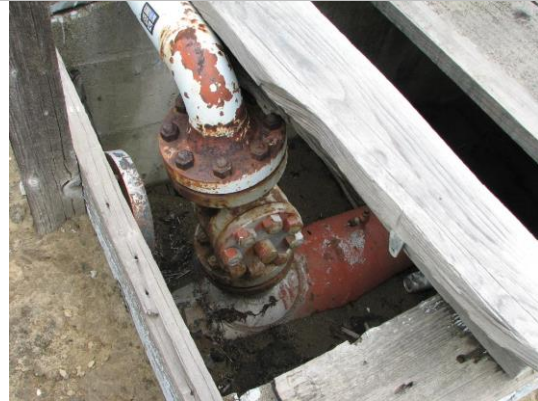
Photo 3 of 3 : UCIP_SP_2017_22074_37674.jpg

| FS_ID:22074 DS_ID:24115 EP_NO: N/A Repair Type: Non-Urgent Crossing Status: Found UCIP Comments: Need to contact owner to determine if crossing is still active and to determine last inspection date. Will need copy of letter showing crossings passed inspection. NEED photo of emergency contact information from marker. FIELD_STRUCT_DESC: 10-inch steel gas line through the levee. Valve in concrete box on the landward side. (USACE-1962). This entry matches the Drainage or Irrigation Structure referenced in O&M manual (HLM 1.42). FS Date: 5/5/2009 | | | | | |

View of pipe inside concrete box located on landward side.

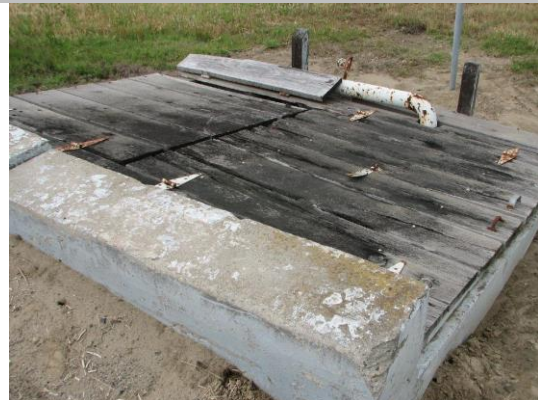
Photo 1 of 3 : UCIP_SP_2017_22076_37680.jpg

| FS_ID:22076 DS_ID:24217 EP_NO: N/A Repair Type: Non-Urgent Crossing Status: Found UCIP Comments: Unknown detail of the size of crossing. Need to contact owner to determine if crossing is still active and to determine last inspection date. Will need copy of letter showing crossings passed inspection. NEED photo of emergency contact information from marker. FIELD_STRUCT_DESC: Gas line through the levee. (USACE-1962). This entry matches the Drainage or Irrigation Structure referenced in O&M manual (HLM 1.44). FS Date: 5/5/2009 | | | | | |

Concrete box located on landward side.

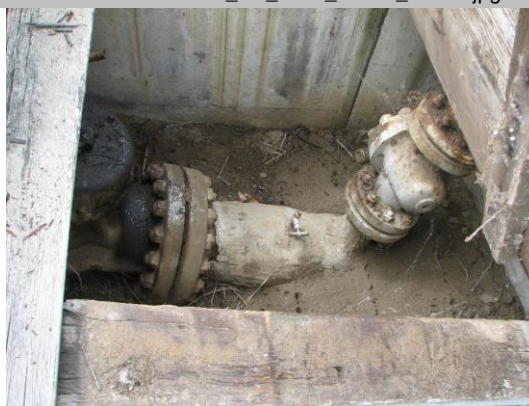
Photo 2 of 3 : UCIP_SP_2017_22076_37677.jpg

| FS_ID:22076 DS_ID:24217 EP_NO: N/A Repair Type: Non-Urgent Crossing Status: Found UCIP Comments: Unknown detail of the size of crossing. Need to contact owner to determine if crossing is still active and to determine last inspection date. Will need copy of letter showing crossings passed inspection. NEED photo of emergency contact information from marker. FIELD_STRUCT_DESC: Gas line through the levee. (USACE-1962). This entry matches the Drainage or Irrigation Structure referenced in O&M manual (HLM 1.44). FS Date: 5/5/2009 | | | | | |

Inside view of vault located on the landward side.

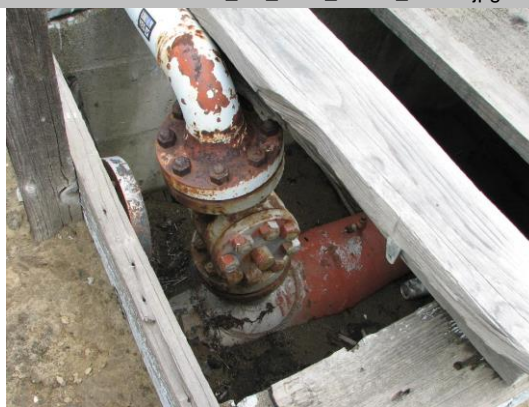
Photo 3 of 3 : UCIP_SP_2017_22076_37679.jpg

View of pipe inside concrete box located on landward side.

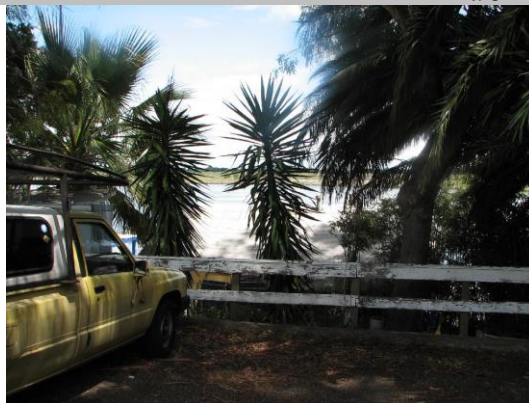
Photo 1 of 3 : UCIP_SP_2017_22086_37706.jpg

| FS_ID:22086 DS_ID:24116 EP_NO: 11103 Repair Type: Non-Urgent Crossing Status: Found UCIP Comments: Unable to determine if crossing is the same as permitted under permit no. 11103. Need to contact owner and determine status of crossing under permit no. 11103. Believe steel conduit is exposed on landward side. FIELD_STRUCT_DESC: 1.5-inch iron water pipe and 3.5-inch electrical steel conduit through the levee, both 3.0 feet below the crown. Pressure system and service pole on landward slope. Fishing resort on waterward side. This pipe was retained under ABO No. 11103 (1975). FS Date: 5/5/2009 | | | | | |

View of waterward side.

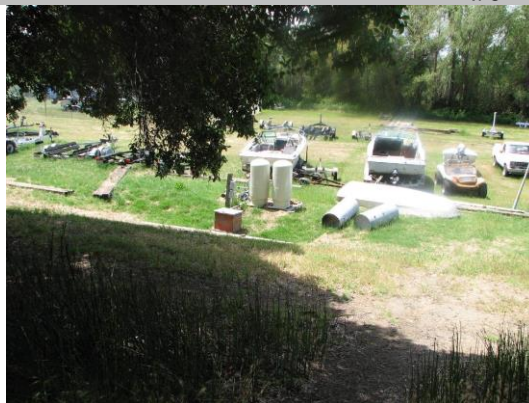
Photo 3 of 3 : UCIP_SP_2017_22086_37703.jpg

| FS_ID:22086 DS_ID:24116 EP_NO: 11103 Repair Type: Non-Urgent Crossing Status: Found UCIP Comments: Unable to determine if crossing is the same as permitted under permit no. 11103. Need to contact owner and determine status of crossing under permit no. 11103. Believe steel conduit is exposed on landward side. FIELD_STRUCT_DESC: 1.5-inch iron water pipe and 3.5-inch electrical steel conduit through the levee, both 3.0 feet below the crown. Pressure system and service pole on landward slope. Fishing resort on waterward side. This pipe was retained under ABO No. 11103 (1975). FS Date: 5/5/2009 | | | | | | |

View of landward side.

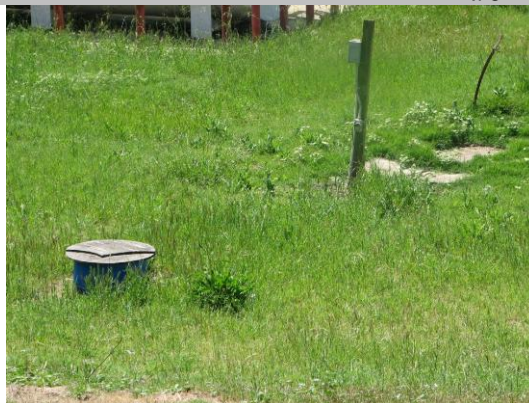
Photo 2 of 3 : UCIP_SP_2017_22091_37711.jpg

| FS_ID:22091 DS_ID:24117 EP_NO: 5427 Repair Type: Non-Urgent Crossing Status: Indicator Found UCIP Comments: Unable to find pipe or sump pump. Indicators found on landward side include potential septic tank and observation well. Need to contact owner of crossing to determine status of crossing. FIELD_STRUCT_DESC: 1 of 2: 4-inch diameter pipe sleeved through 6-inch pipe through the levee, 3.7 feet below the crown. Sump pump on waterward slope. Septic tank and observation well on the landward side. (Permit No. 5427-1966) FS Date: 5/5/2009 | | | | | |

Stand pipe (potential observation well) and concrete pad located on landward side.

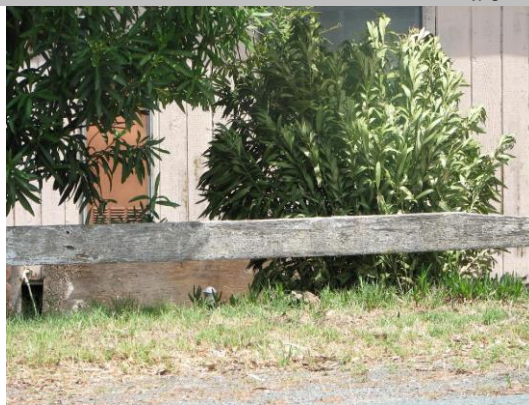
Photo 3 of 3 : UCIP_SP_2017_22091_37710.jpg

View of waterward side.

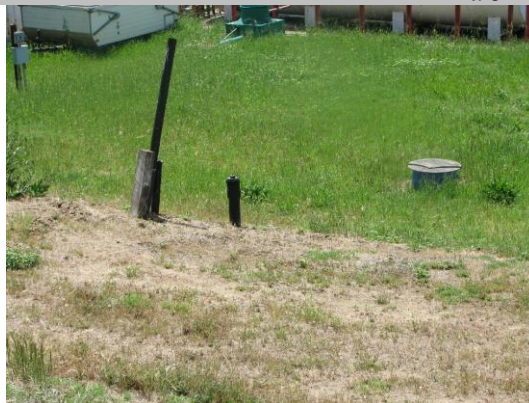
Photo 1 of 2 : UCIP_SP_2017_22093_37717.jpg

Electrical conduit and box located on left corner of picture.

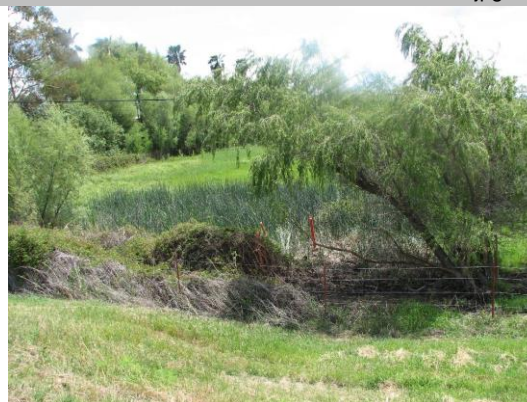
Photo 2 of 2 : UCIP_SP_2017_22094_37718.jpg

FS_ID:22094
DS_ID:24119
EP_NO: 960
Repair Type: Non-Urgent
Crossing Status: Indicator Found
UCIP Comments: Need to contact owner to determine last inspection and status of crossing.
FIELD_STRUCT_DESC: 1 of 2: 10-inch gas line through the levee, 2.0 feet below the crown. Cutoff wall around pipes at center of levee. Valve pit on landward shoulder, with 2-inch drain pipe along landward slope. Contact information for PG&E 800-811-4111. Location marker on waterward slope. (Permit No. 960-1944) This entry matches the Drainage or Irrigation Structure referenced in O&M manual (HLM 2.04). Pipe video inspected by PG&E under Permit No. 15319 (1990).
FS Date: 5/5/2009

Landward markers visible near levee toe.

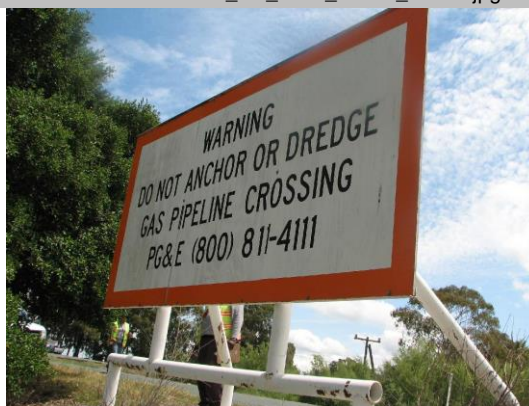
Photo 1 of 2 : UCIP_SP_2017_22098_37724.jpg

| FS_ID:22098 DS_ID:24242 EP_NO: 960 Repair Type: Non-Urgent Crossing Status: Indicator Found UCIP Comments: Need to contact owner to determine last inspection and status of crossing. FIELD_STRUCT_DESC: 2 of 2: 10-inch gas line through the levee, 2.0 feet below the crown. Cutoff wall around pipes at center of levee. Valve pit on landward shoulder, with 2-inch drain pipe along landward slope. Location marker on waterward slope. (Permit No. 960-1944) This entry matches the Drainage or Irrigation Structure referenced in O&M manual (HLM 2.04). Pipe video inspected by PG&E under Permit No. 15319 (1990). FS Date: 5/5/2009 | | | | | |

Warning marker visible on waterward shoulder.

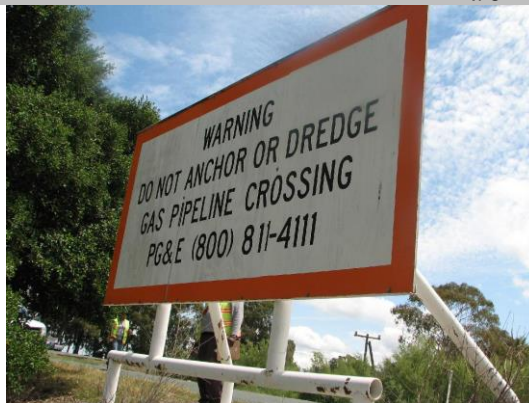
Photo 1 of 2 : UCIP_SP_2017_39860_71847.jpg

View of sign located on waterward side.

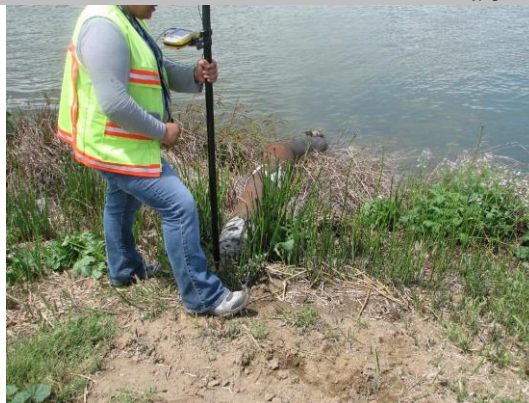
Photo 1 of 3 : UCIP_SP_2017_22106_37734.jpg

View of pipe on waterward side.

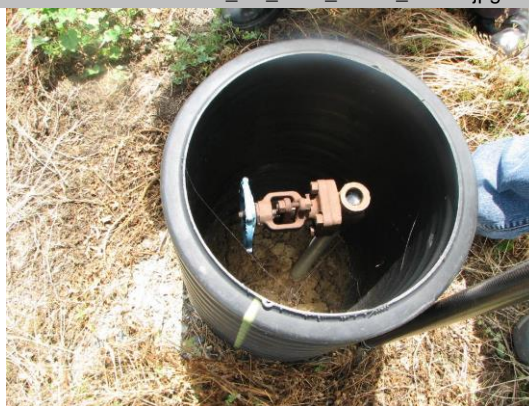
Photo 3 of 3 : UCIP_SP_2017_22106_37732.jpg

Siphon breaker located on landward slope.

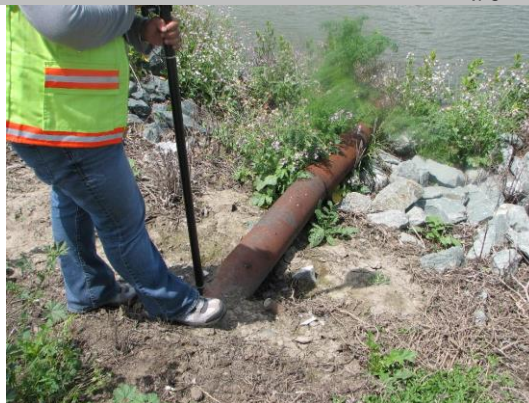
Photo 1 of 3 : UCIP_SP_2017_22112_37750.jpg

View of pipe and rip rap located on waterward side.

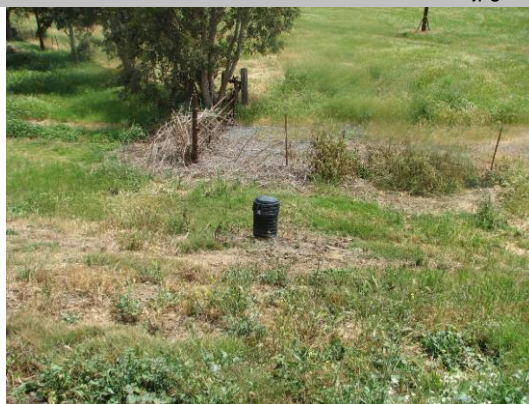
Photo 2 of 3 : UCIP_SP_2017_22112_37748.jpg

Stand pipe located near levee toe on landward side.

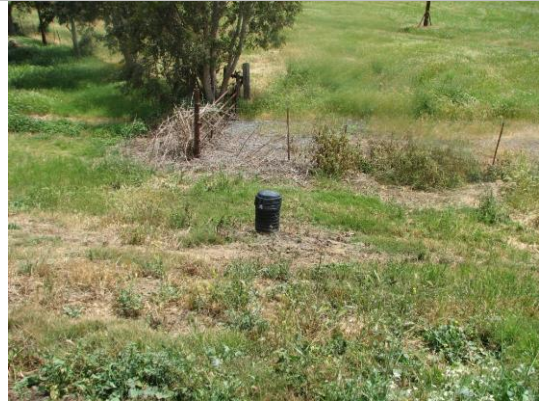
Photo 3 of 3 : UCIP_SP_2017_22116_37756.jpg

| FS_ID:22116 DS_ID:24238 EP_NO: N/A Repair Type: Non-Urgent Crossing Status: Indicator Found UCIP Comments: Pipe side does not match--found 10 inch instead of 8 inch. Pipe (2 of 2) was supposed to be removed and replaced with 12-inch steel irrigation pipes under Permit No. 5629 (1966). Historical Levee Logs from 1992 do not reflect that the replacement was completed, verify diameter of pipes and status with applicant. Dense vegetation limits the inspector's visibility to identify signs of pipe failure (leaks) along the slope. Recommend removing vegetation along pipe alignment to conduct proper inspection of structure and appurtenances. FIELD_STRUCT_DESC: 2 of 2: 10-inch (not 8-inch as originally mentioned in desk study) steel irrigation pipe through the levee, 1.6 feet below the crown. Siphon breaker on landward side. Irrigation ditch with distribution box at landward toe. Pipe exposed on both slopes. Rock revetment on waterward slope. (USACE-1962). This entry matches the Drainage or Irrigation Structure referenced in O&M manual (HLM 2.93). FS Date: 5/5/2009 | | | | | | |

Stand pipe located near levee toe on landward side.

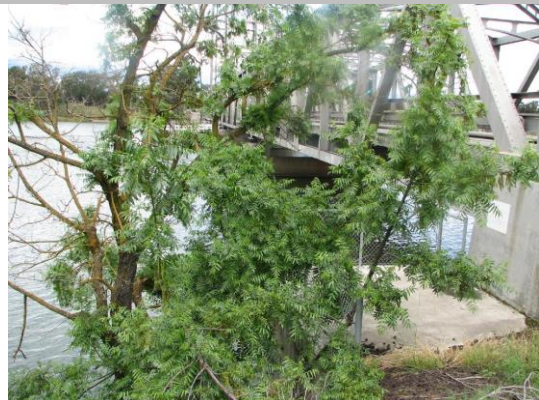
Photo 1 of 3 : UCIP_SP_2017_22183_37780.jpg

| FS_ID:22183 DS_ID:24245 EP_NO: N/A Repair Type: Non-Urgent Crossing Status: Found UCIP Comments: New crossing found in field--need to find owner and determine permit authorizing work. FIELD_STRUCT_DESC: 10-inch corrugated metal pipe extruding from the waterward slope. FS Date: 5/5/2009 | | | | | |

View of waterward side.

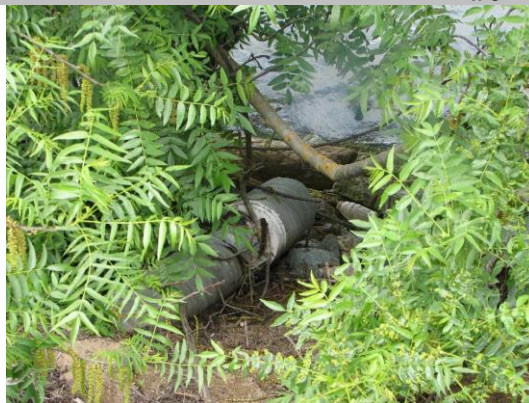
Photo 2 of 3 : UCIP_SP_2017_22183_37783.jpg

| FS_ID:22183 DS_ID:24245 EP_NO: N/A Repair Type: Non-Urgent Crossing Status: Found UCIP Comments: New crossing found in field--need to find owner and determine permit authorizing work. FIELD_STRUCT_DESC: 10-inch corrugated metal pipe extruding from the waterward slope. FS Date: 5/5/2009 | | | | | | |

Pipe on waterward side.

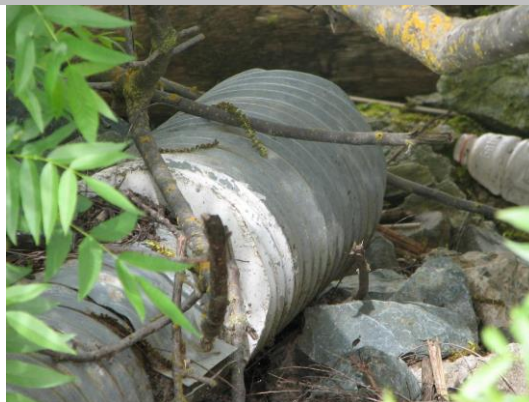
Photo 3 of 3 : UCIP_SP_2017_22183_37781.jpg

View of corrugated metal pipe on waterward side.

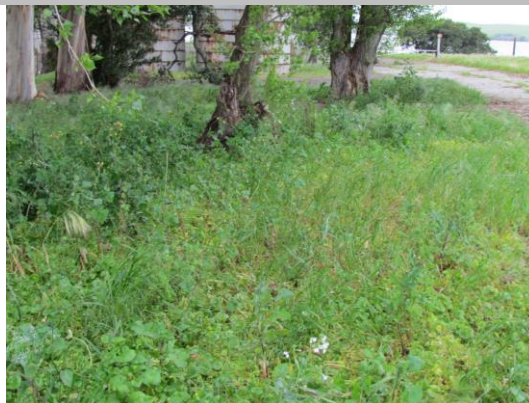
Photo 1 of 1 : SP_2017_RD0341_168_36_20170510_00082.jpg

RD 341 Unit 2 standing at levee mile 3.36 landside shoulder, tall weeds present on shoulder and slope.

| Remove the tall weed growth from the landside levee slope and shoulder. | | | | | |

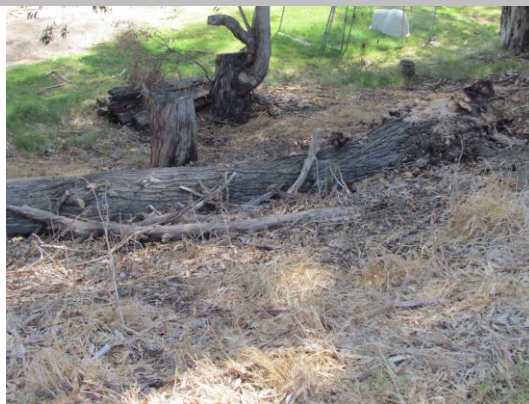
Photo 1 of 1 : SP_2017_RD0341_168_37_20170404_00005.jpg

RD 341 landside levee mile 3.45.

| Remove the dead fallen tree from the landside slope. | | | | | |

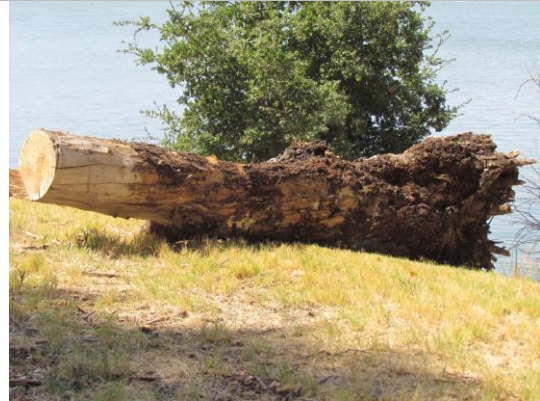
Photo 1 of 1 : SP_2017_RD0341_168_38_20170404_00006.jpg

RD 341 Waterside slope looking downstream levee mile 3.52.

| Remove the dead fallen tree on the waterside slope. | | | | | |

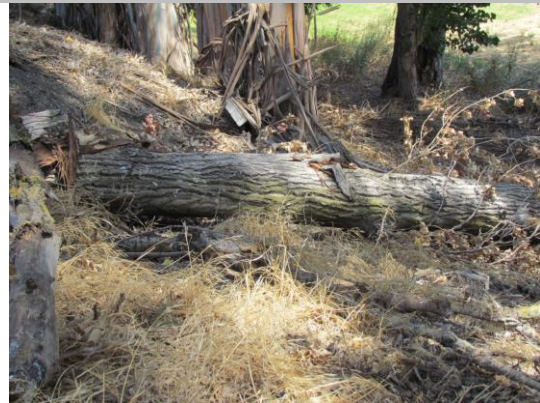
Photo 1 of 1 : SP_2017_RD0341_168_39_20170404_00007.jpg

RD 341 Looking downstream from levee mile 3.52 landside slope. No change 4-7-2017.

| Remove the fallen dead tree from the landside levee slope. This tree has not been removed as of the last inspection 4-7-2017. | | | | | |

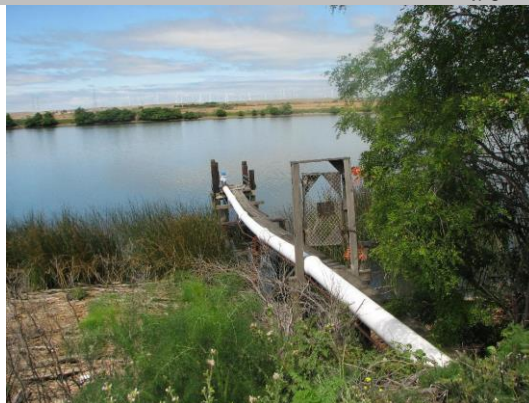
Photo 1 of 1 : UCIP_SP_2017_22223_37840.jpg

| FS_ID:22223 DS_ID:24122 EP_NO: 11106 Repair Type: Non-Urgent Crossing Status: Found UCIP Comments: Need to contact owner to determine status of crossing. Dense vegetation limits the inspector's visibility to identify signs of pipe failure (leaks) along the slope. Recommend removing vegetation along pipe alignment to conduct proper inspection of structure and appurtenances. FIELD_STRUCT_DESC: 12-inch pipe through the levee, 4.0 feet below the crown. Pump on pile structure in stream. (USACE-1962). This entry matches the Drainage or Irrigation Structure referenced in O&M manual (HLM 4.29). 12-inch pipe was retained under ABO No. 11106 (1975). FS Date: 5/6/2009 | | | | | |

View of waterward side--pipe and pump visible.

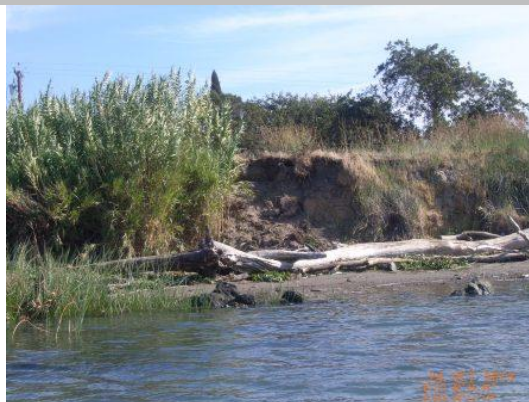
Photo 1 of 1 : SP_2017_RD0341_168_3_20170404_00002.jpg

| 1999 - New small slump in eroded bank. 2005 - Reach extended because of vertical bank along the roadway upstream. 2011 - More slumping since last year. 2012 - Site upgraded to critical. Very steep slope which may be effecting the highway on top of the levee. 2015: New erosion towards downstream end of site. [2015 Site ID: SAC_8-0_L] | | | | | |

USACE 2013 Photo #1

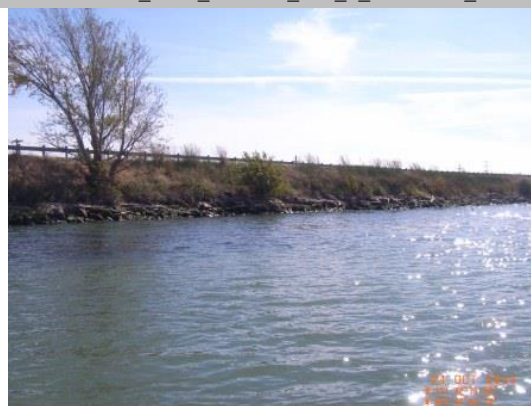
Photo 1 of 1 : SP_2017_RD0341_168_4_20170404_00003.jpg

| 2011 - Large slump section. 2012 - Site extended downstream, upgraded to critical, severe windwave. Slope is very steep and may be effecting the highway on top of the levee. 2015: No observed changes. [2015 Site ID: SAC_7-9_L] | | | | | |

USACE 2013 Photo #1

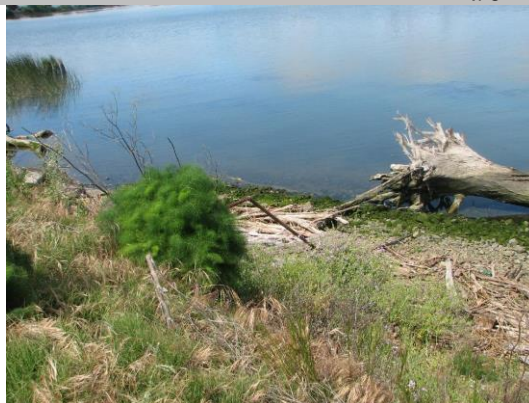
Photo 2 of 2 : UCIP_SP_2017_22186_37786.jpg

| FS_ID:22186 DS_ID:24123 EP_NO: 4855 Repair Type: Non-Urgent Crossing Status: Found UCIP Comments: Dense vegetation limits the inspector's visibility to identify signs of pipe failure (leaks) along the slope. Recommend removing vegetation along pipe alignment to conduct proper inspection of structure and appurtenances. FIELD_STRUCT_DESC: 2-inch steel irrigation pipe through the levee, 3.0 feet below the crown. Valve and pump on landward side. Rock revetment on waterward slope. (Permit No. 4855-1965) FS Date: 5/6/2009 | | | | | | |

View of waterward toe.

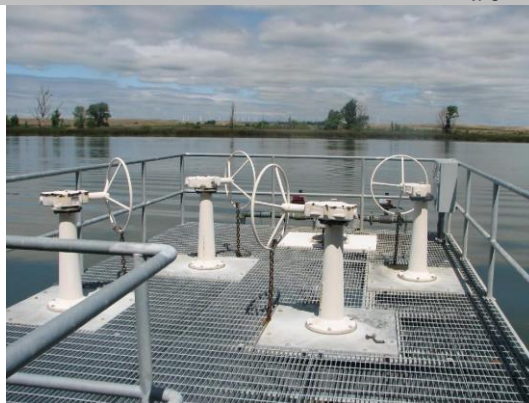
Photo 3 of 3 : UCIP_SP_2017_22253_37881.jpg

| UCIP Comments: Dense vegetation limits the inspector's visibility to identify signs of pipe failure (leaks) along the slope. Recommend removing vegetation along pipe alignment to conduct proper inspection of structure and appurtenances. | | | | | | |

Gates located on waterward side.

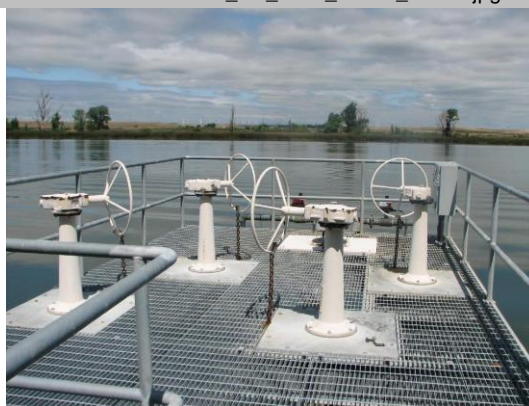
Photo 3 of 3 : UCIP_SP_2017_22255_37908.jpg

| FS_ID:22255 DS_ID:24240 EP_NO: 15175 Repair Type: Non-Urgent Crossing Status: Found UCIP Comments: Dense vegetation limits the inspector's visibility to identify signs of pipe failure (leaks) along the slope. Recommend removing vegetation along pipe alignment to conduct proper inspection of structure and appurtenances. FIELD_STRUCT_DESC: 3 of 4: 24-inch steel irrigaiton pipe in 30-inch steel casings through the levee, 6.6 feet below the crown. Annular gap grouted. Siphon breakers at waterward shoulder, with concrete risers on both ends. Screened inlet manifold (36-inch) with backwash system on pile structure in stream. Surrounded by fence with entry gate. Irrigation pond at landward toe. (Permit No. 15175-1993). Structure in stream installed under Permit No. 16737 (2000). FS Date: 5/6/2009 | | | | | | |

Gates located on waterward side.

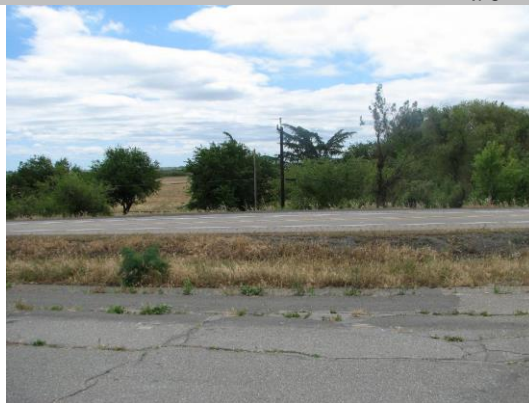
Photo 1 of 3 : UCIP_SP_2017_22256_37915.jpg

| FS_ID:22256 DS_ID:24127 EP_NO: 11116 Repair Type: Non-Urgent Crossing Status: Found UCIP Comments: Need to coordinate with owner to determine status of crossing. If crossing is no longer in use owner will need to contact the CVFPB to comply with Title 23. Dense vegetation limits the inspector's visibility to identify signs of pipe failure (leaks) along the slope. Recommend removing vegetation along pipe alignment to conduct proper inspection of structure and appurtenances. FIELD_STRUCT_DESC: 16-inch pipe sleeved through 18-inch pipe through the levee, 2.5 feet below the crown. Annular gap grouted. Air vent on waterward side. (USACE-1962). This entry matches the Drainage or Irrigation Structure referenced in O&M manual (HLM 5.40). This pipe was retained under ABO No. 11116 (1975). Annular gap grouted and pipe lengthened under Permit No. 15372 (1993). FS Date: 5/6/2009 | | | | | |

Overview of levee crown at crossing.

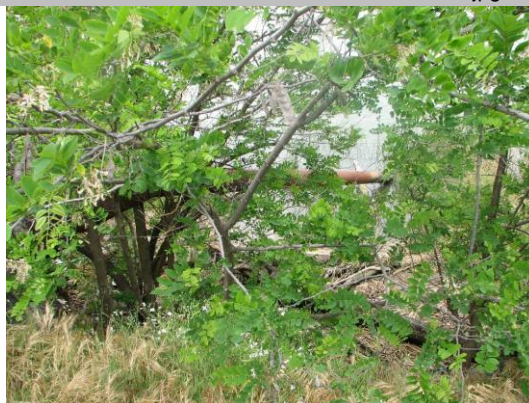
Photo 2 of 3 : UCIP_SP_2017_22256_37914.jpg

View of pipe through brush on waterward side.

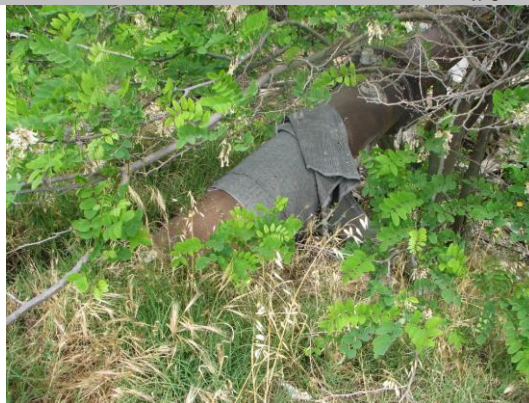
Photo 3 of 3 : UCIP_SP_2017_22256_37917.jpg

| FS_ID:22256 DS_ID:24127 EP_NO: 11116 Repair Type: Non-Urgent Crossing Status: Found UCIP Comments: Need to coordinate with owner to determine status of crossing. If crossing is no longer in use owner will need to contact the CVFPB to comply with Title 23. Dense vegetation limits the inspector's visibility to identify signs of pipe failure (leaks) along the slope. Recommend removing vegetation along pipe alignment to conduct proper inspection of structure and appurtenances. FIELD_STRUCT_DESC: 16-inch pipe sleeved through 18-inch pipe through the levee, 2.5 feet below the crown. Annular gap grouted. Air vent on waterward side. (USACE-1962). This entry matches the Drainage or Irrigation Structure referenced in O&M manual (HLM 5.40). This pipe was retained under ABO No. 11116 (1975). Annular gap grouted and pipe lengthened under Permit No. 15372 (1993). FS Date: 5/6/2009 | | | | | | |

Pipe on waterward side at daylight.

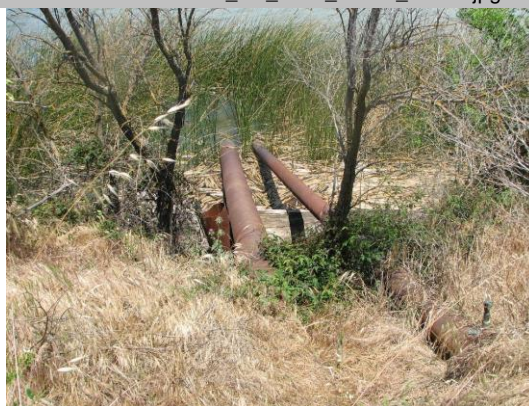
Photo 1 of 3 : UCIP_SP_2017_22258_37932.jpg

| FS_ID:22258 DS_ID:24074 EP_NO: 11116 Repair Type: Non-Urgent Crossing Status: Found UCIP Comments: Dense vegetation limits the inspector's visibility to identify signs of pipe failure (leaks) along the slope. Recommend removing vegetation along pipe alignment to conduct proper inspection of structure and appurtenances. FIELD_STRUCT_DESC: 1 of 2: 8-inch pipe sleeved through 10-inch pipe through levee, 2.5 feet below the crown. Annular gap grouted. Concrete distribution box with slide gate at landward toe. Air vent on waterward side. (USACE-1962). This entry matches the Drainage or Irrigation Structure referenced in O&M manual (HLM 5.81). This pipe was retained under ABO No. 11116 (1975). Distributon box installed and pipe along landward slope removed and replaced with longer 10-inch steel pipe under Permit No. 15372 (1993). FS Date: 5/6/2009 | | | | | |

8-inch pipe and 14-inch pipe on waterward side.

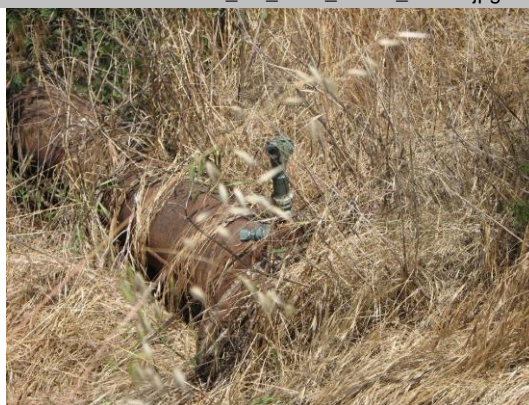
Photo 2 of 3 : UCIP_SP_2017_22258_37930.jpg

Air vent located on waterward side.

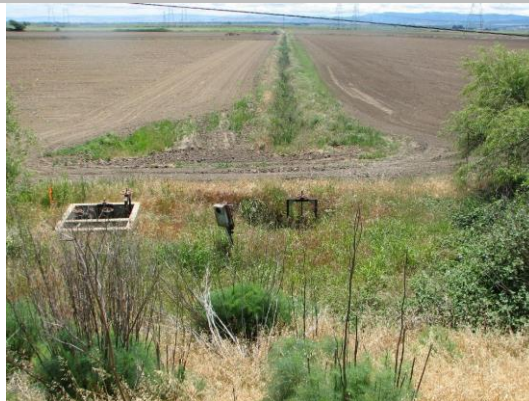
Photo 3 of 3 : UCIP_SP_2017_22258_37931.jpg

| FS_ID:22258 DS_ID:24074 EP_NO: 11116 Repair Type: Non-Urgent Crossing Status: Found UCIP Comments: Dense vegetation limits the inspector's visibility to identify signs of pipe failure (leaks) along the slope. Recommend removing vegetation along pipe alignment to conduct proper inspection of structure and appurtenances. FIELD_STRUCT_DESC: 1 of 2: 8-inch pipe sleeved through 10-inch pipe through levee, 2.5 feet below the crown. Annular gap grouted. Concrete distribution box with slide gate at landward toe. Air vent on waterward side. (USACE-1962). This entry matches the Drainage or Irrigation Structure referenced in O&M manual (HLM 5.81). This pipe was retained under ABO No. 11116 (1975). Distributon box installed and pipe along landward slope removed and replaced with longer 10-inch steel pipe under Permit No. 15372 (1993). FS Date: 5/6/2009 | | | | | | |

View of landward side.

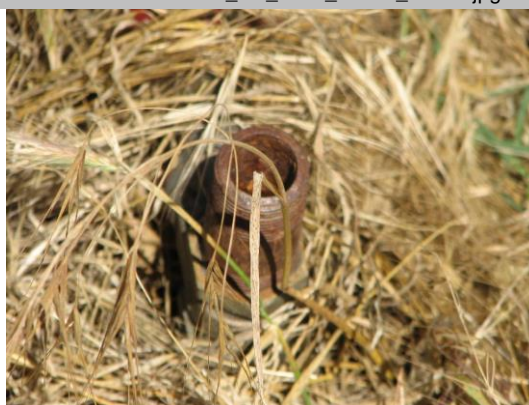
Photo 2 of 3 : UCIP_SP_2017_22259_37936.jpg

Air vent located on waterward side.

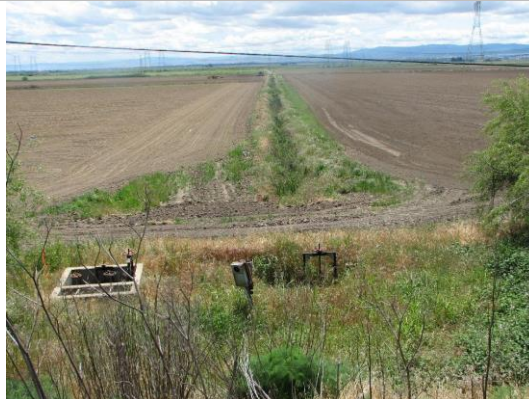
Photo 3 of 3 : UCIP_SP_2017_22259_37934.jpg

| UCIP Comments: Dense vegetation limits the inspector's visibility to identify signs of pipe failure (leaks) along the slope. Recommend removing vegetation along pipe alignment to conduct proper inspection of structure and appurtenances. | | | | | | |

Gate located at the toe of the levee on landward side.

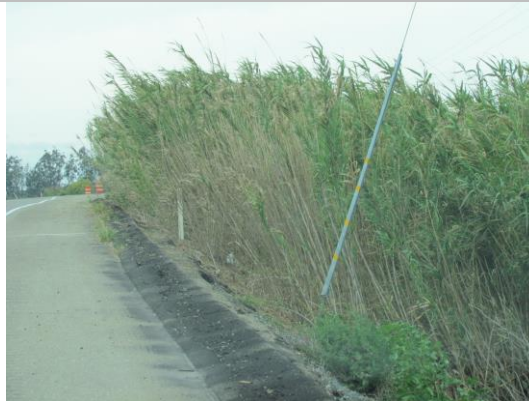
Photo 1 of 1 : SP_2017_RD0341_168_49_20170516_00084.jpg

RD 341 Landside slope from levee mile 6.03-6.10 tall unwanted growth of Arundo present on the levee section.

| Remove the bamboo from the landside levee slope. | | | | | |

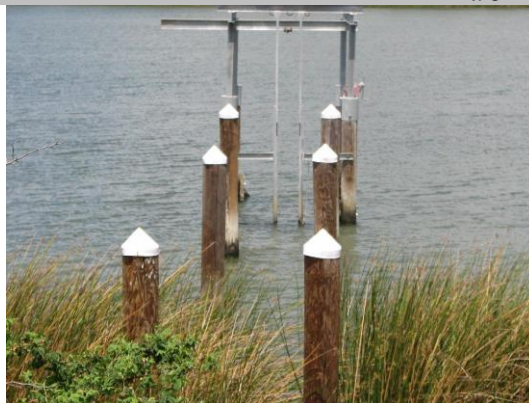
Photo 1 of 3 : UCIP_SP_2017_39861_71853.jpg

FS_ID:39861
DS_ID:24076
EP_NO: 11116
Repair Type: Non-Urgent
Crossing Status: Found
UCIP Comments: Need to contact owner to determine status of crossing. If crossing is no longer used will need to meet Title 23 requirements. Hole present in pipe section. Debris on waterward side-- 10-inch pipe section abandoned on slope. Dense vegetation limits the inspector's visibility to identify signs of pipe failure (leaks) along the slope. Recommend removing vegetation along pipe alignment to conduct proper inspection of structure and appurtenances.
FIELD_STRUCT_DESC: 12-inch pipe sleeved through 14-inch pipe through levee, 4.0 feet below crown. Annular gap grouted. Slide gate in distribution box on landward side. (USACE-1962). This entry matches the Drainage or Irrigation Structure referenced in O&M manual (HLM 6.12). This pipe was retained under ABO No. 11116 (1975). Distributon box installed and pipe along landward slope removed and replaced with longer 16-inch steel pipe under Permit No. 15372 (1993).

View of structure located on waterward side.

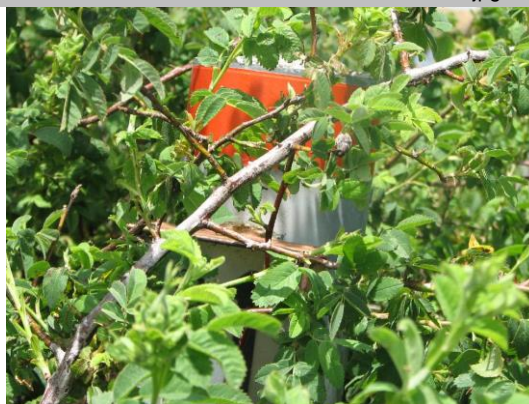
Photo 2 of 3 : UCIP_SP_2017_39861_71852.jpg

Marker visible on waterward side associated with crossing.

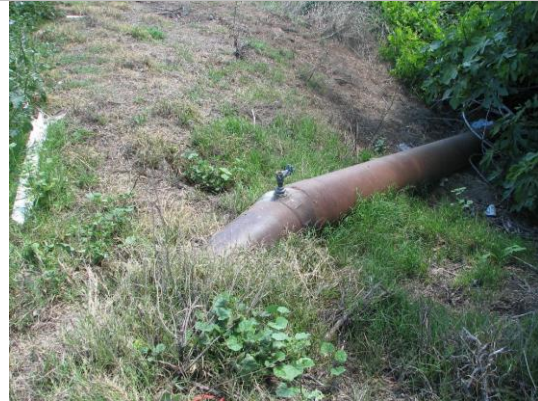
Photo 3 of 3 : UCIP_SP_2017_22261_37948.jpg

| UCIP Comments: Dense vegetation limits the inspector's visibility to identify signs of pipe failure (leaks) along the slope. Recommend removing vegetation along pipe alignment to conduct proper inspection of structure and appurtenances. | | | | | | |

View of crossing on landward slope.

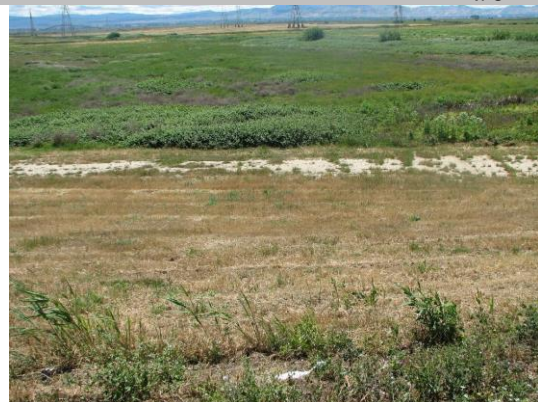
Photo 1 of 2 : UCIP_SP_2017_22262_37953.jpg

| FS_ID:22262 DS_ID:24079 EP_NO: 11107 Repair Type: Non-Urgent Crossing Status: Indicator Found UCIP Comments: Need to contact owner to determine status of crossing. If crossing is no longer in used owner will need to comply with Title 23. Dense vegetation limits the inspector's visibility to identify signs of pipe failure (leaks) along the slope. Recommend removing vegetation along pipe alignment to conduct proper inspection of structure and appurtenances. FIELD_STRUCT_DESC: 4-inch pipe through the levee, 4.0 feet below the crown. This pipe was retained under ABO No. 11107 (1975). FS Date: 5/6/2009 | | | | | |

View of landward side no evidence of crossing.

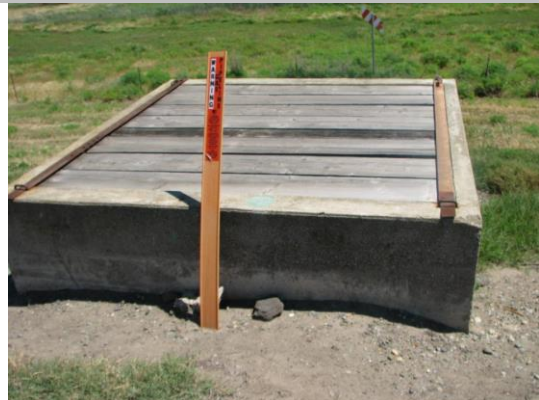
Photo 1 of 3 : UCIP_SP_2017_22263_37962.jpg

| FS_ID:22263 DS_ID:24081 EP_NO: 892 Repair Type: Non-Urgent Crossing Status: Found UCIP Comments: Need to contact owner to determine status of crossing. Need date of last inspection and confirmation that crossing is still in operable condition. FIELD_STRUCT_DESC: 1 of 2: 12.75-inch steel gas line through the levee, 2.0 feet below the crown. Concrete cutoff wall around pipes at center of levee. Location marker on waterward slope. Concrete control box and valve pit on landward slope. (Permit No. 892-1942) Utility marker contact information includes Contact prior to Excavation call 1-800-227-2600 or Emergency Contact 1-800-811-4111. FS Date: 5/6/2009 | | | | | |

View of landward side. Concrete box and markers indicating gas pipeline. Additional marker located at levee toe.

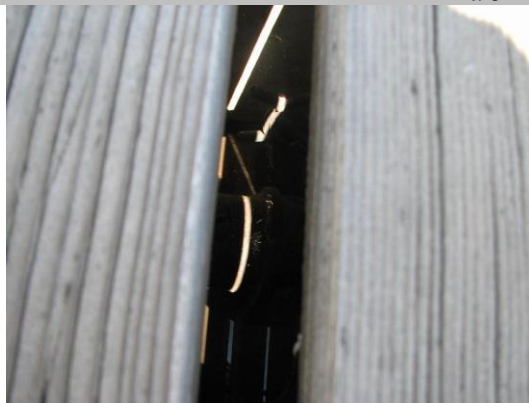
Photo 2 of 3 : UCIP_SP_2017_22263_37961.jpg

| UCIP Comments: Need to contact owner to determine status of crossing. Need date of last inspection and confirmation that crossing is still in operable condition. | | | | | | |

Unable to confirm number of pipes.

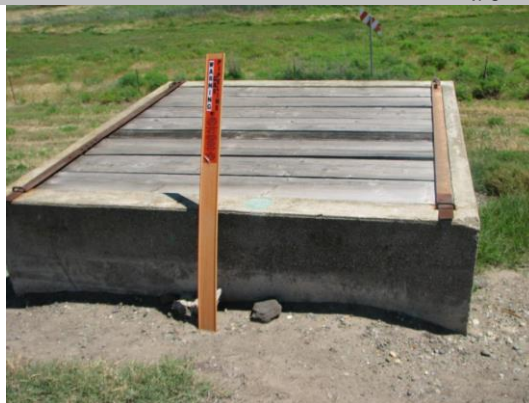
Photo 1 of 3 : UCIP_SP_2017_22264_37965.jpg

| FS_ID:22264 DS_ID:24234 EP_NO: 892 Repair Type: Non-Urgent Crossing Status: Found UCIP Comments: Need to contact owner to determine status of crossing. Need date of last inspection and confirmation that crossing is still in operable condition. FIELD_STRUCT_DESC: 2 of 2: 12.75-inch steel gas line through the levee, 2.0 feet below the crown. Concrete cutoff wall around pipes at center of levee. Location marker on waterward slope. Concrete control box and valve pit on landward slope. (Permit No. 892-1942) Utility marker contact information includes Contact prior to Excavation call 1-800-227-2600 or Emergency Contact 1-800-811-4111. FS Date: 5/6/2009 | | | | | |

Concrete box and marker located on near landward shoulder. Additional marker located at the levee toe.

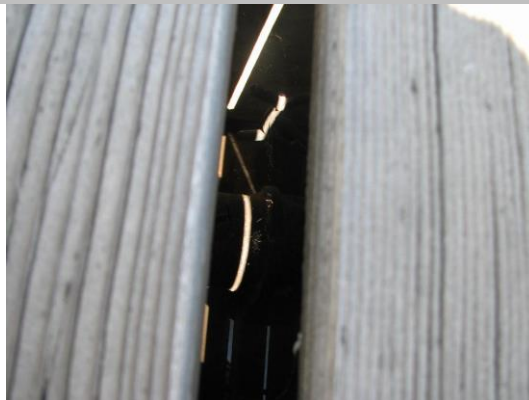
Photo 2 of 3 : UCIP_SP_2017_22264_37964.jpg

Unable to confirm the number of pipe through section of levee.

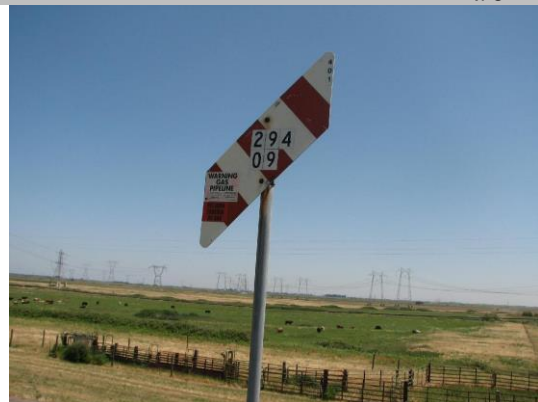
Photo 1 of 2 : UCIP_SP_2017_22267_37978.jpg

| FS_ID:22267 DS_ID:24193 EP_NO: 15777 Repair Type: Non-Urgent Crossing Status: Indicator Found UCIP Comments: Need to contact owner to determine status of crossing. Need date of last inspection and confirmation that crossing is still in operable condition. Multiple crossings in general area need to clarify which pipes are in this levee section. FIELD_STRUCT_DESC: 42-inch steel gas pipeline throught the levee, approximately 30.0 feet below the crown. (Permit No. 15777-1993) Utility marker contact information includes Contact prior to Excavation call 1-800-227-2600 or Emergency Contact 1-800-811-4111. FS Date: 5/6/2009 | | | | | |

Marker located on landward side.

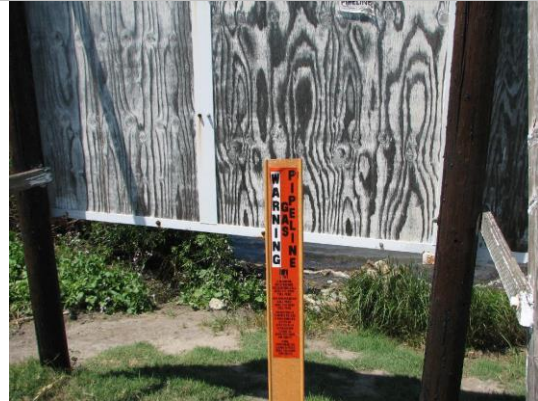
Photo 2 of 2 : UCIP_SP_2017_22267_37977.jpg

| UCIP Comments: Need to contact owner to determine status of crossing. Need date of last inspection and confirmation that crossing is still in operable condition. Multiple crossings in general area need to clarify which pipes are in this levee section. | | | | | |

Marker located on waterward side.

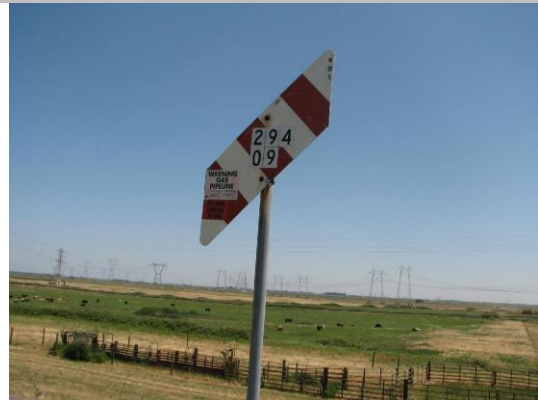
Photo 1 of 2 : UCIP_SP_2017_22268_37980.jpg

| FS_ID:22268 DS_ID:24218 EP_NO: N/A Repair Type: Non-Urgent Crossing Status: Indicator Found UCIP Comments: Need to contact owner to determine status of crossing. Need date of last inspection and confirmation that crossing is still in operable condition. Multiple crossings in general area need to clarify which pipes are in this levee section. FIELD_STRUCT_DESC: Gas line crossing through the levee. (USACE-1962). This entry matches the Drainage or Irrigation Structure referenced in O&M manual (HLM 7.08). Utility marker contact information includes Contact prior to Excavation call 1-800-227-2600 or Emergency Contact 1-800-743-5000. FS Date: 5/6/2009 | | | | | |

Utility marker located on landward side.

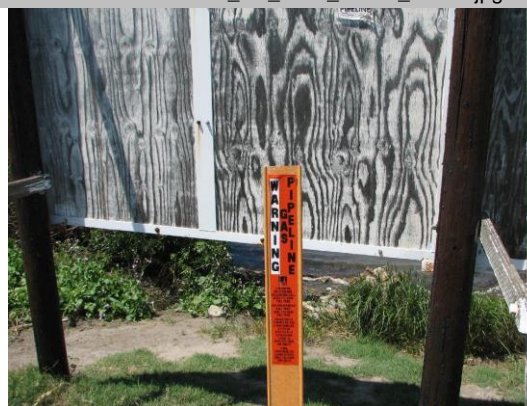
Photo 2 of 2 : UCIP_SP_2017_22268_37979.jpg

| FS_ID:22268 DS_ID:24218 EP_NO: N/A Repair Type: Non-Urgent Crossing Status: Indicator Found UCIP Comments: Need to contact owner to determine status of crossing. Need date of last inspection and confirmation that crossing is still in operable condition. Multiple crossings in general area need to clarify which pipes are in this levee section. FIELD_STRUCT_DESC: Gas line crossing through the levee. (USACE-1962). This entry matches the Drainage or Irrigation Structure referenced in O&M manual (HLM 7.08). Utility marker contact information includes Contact prior to Excavation call 1-800-227-2600 or Emergency Contact 1-800-743-5000. FS Date: 5/6/2009 | | | | | | |

Utility marker located on waterward side.

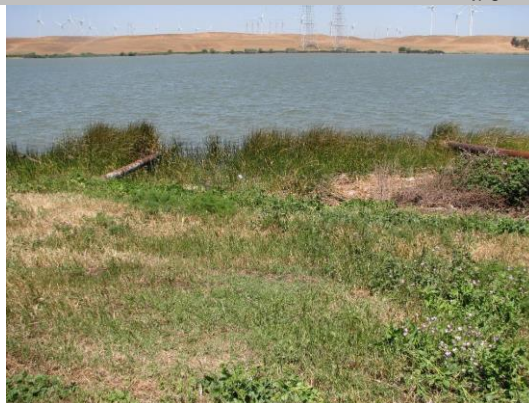
Photo 1 of 3 : UCIP_SP_2017_22293_38041.jpg

| FS_ID:22293 DS_ID:24128 EP_NO: 1915 Repair Type: Non-Urgent Crossing Status: Found UCIP Comments: Will need to contact owner. Need to obtain maintenance records and clarify modifications made at to crossing (size). Also important to note that DWR DOE was out in the field during our pipe inspection they were conducting pipe evaluation for pipe replacement. Need to contact DWR DOE to determine location of pipe replacement. FIELD_STRUCT_DESC: 18-inch (not 12-inch as noted in historical records) steel irrigation pipe through the levee, 3.0 feet below the crown. Concrete pipe riser on landward side. (Permit No. 1352-1948) Siphon breaker on landward side installed under Permit No. 1915 (1954). Pipe removed and replaced by 12-inch steel pipe under Permit No. 10799 (1977). FS Date: 5/6/2009 | | | | | |

Overview of waterward side-18-inch pipe located on right side and 12-inch pipe located on left side.

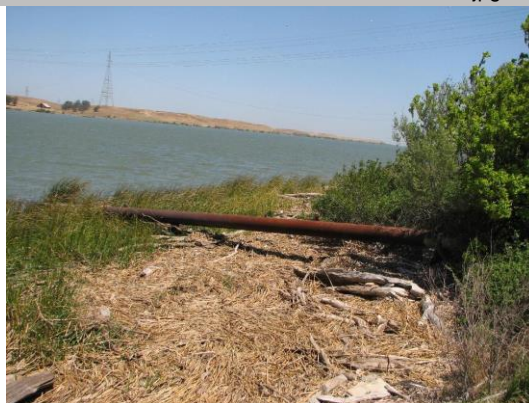
Photo 2 of 3 : UCIP_SP_2017_22293_38040.jpg

View of crossing located on waterward side.

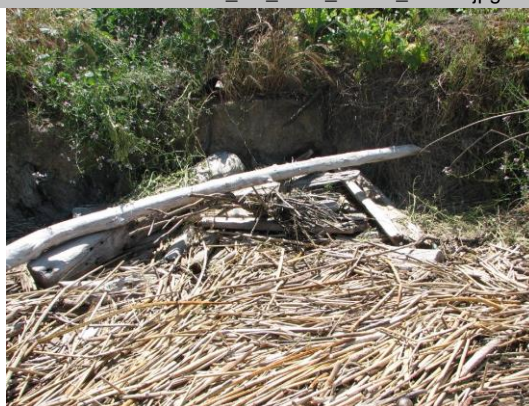
Photo 3 of 3 : UCIP_SP_2017_22293_38044.jpg

| FS_ID:22293 DS_ID:24128 EP_NO: 1915 Repair Type: Non-Urgent Crossing Status: Found UCIP Comments: Will need to contact owner. Need to obtain maintenance records and clarify modifications made at to crossing (size). Also important to note that DWR DOE was out in the field during our pipe inspection they were conducting pipe evaluation for pipe replacement. Need to contact DWR DOE to determine location of pipe replacement. FIELD_STRUCT_DESC: 18-inch (not 12-inch as noted in historical records) steel irrigation pipe through the levee, 3.0 feet below the crown. Concrete pipe riser on landward side. (Permit No. 1352-1948) Siphon breaker on landward side installed under Permit No. 1915 (1954). Pipe removed and replaced by 12-inch steel pipe under Permit No. 10799 (1977). FS Date: 5/6/2009 | | | | | | |

Concrete headwall found on waterward side.

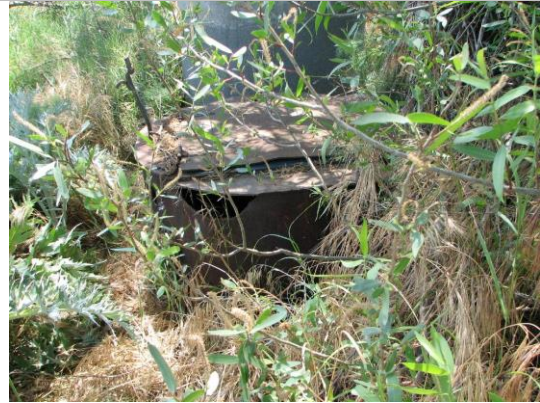
Photo 3 of 3 : UCIP_SP_2017_22294_38047.jpg

| FS_ID:22294 DS_ID:24243 EP_NO: 10799 Repair Type: Non-Urgent Crossing Status: Found UCIP Comments: Will need to contact owner. Need to obtain maintenance records and clarify modifications made at to crossing (size). Also important to note that DWR DOE was out in the field during our pipe inspection they were conducting pipe evaluation for pipe replacement. Need to contact DWR DOE to determine location of pipe replacement. FIELD_STRUCT_DESC: 12-inch steel irrigation pipe through the levee, 5.3 feet below the crown. Steel cutoff wall around pipe at center of levee. Siphon breaker on landward shoulder. Steel (not concrete as mentioned in historical records) pipe riser on landward side. 2-inch pipe sleeve around pipe at waterward shoulder. Rock revetment on waterward slope. Pipe exposed along waterward slope. (Permit No. 10799-1977) FS Date: 5/6/2009 | | | | | |

Steel stand pipe located on landward side near levee toe.

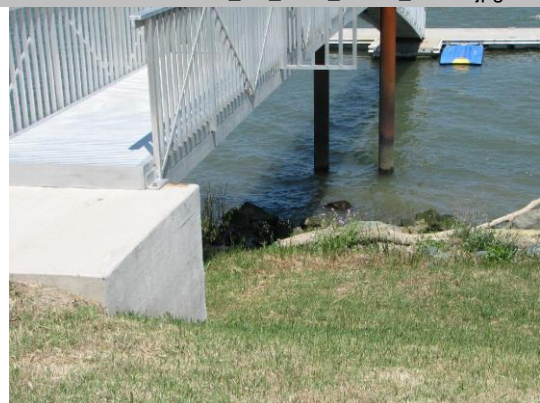
Photo 1 of 3 : UCIP_SP_2017_22303_38062.jpg

View of waterward side. Conduit goes through concrete structure connecting walkway.

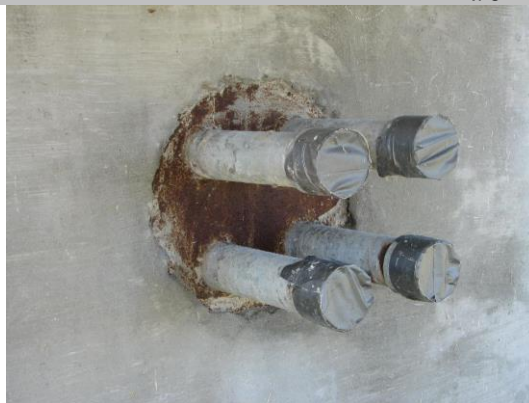
Photo 2 of 3 : UCIP_SP_2017_22303_38061.jpg

Conduits exposed on waterward side.

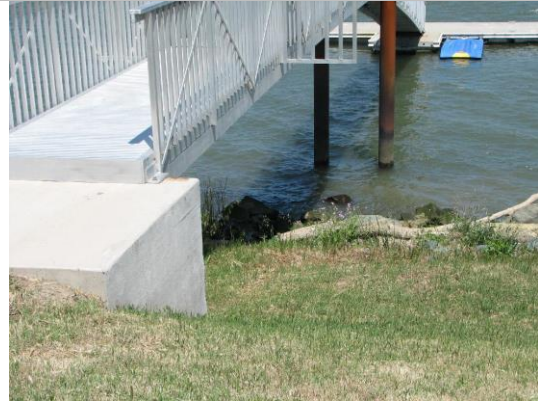
Photo 1 of 1 : UCIP_SP_2017_22305_38064.jpg

| FS_ID:22305 DS_ID:24221 EP_NO: 17728 Repair Type: Non-Urgent Crossing Status: Not Found UCIP Comments: Need to clarify if three 2-inch steel conduits were installed. This permit appears to be associated with the dock installed at levee mile 7.91. See inspection sheet for LM 7.91. FIELD_STRUCT_DESC: Three 2-inch steel electric conduits encased in a single 6-inch steel conduit through the levee, 2.0 feet below the crown. Gaps filled with grout. Boat dock (60x8 feet) and landing on steel pilings in the channel. Metal bridge, concrete landing on pilings and foot paths on the waterward slope. Rock revetment on waterward slope. (Permit No. 17728-2004) FS Date: 5/6/2009 | | | | | |

Dock installed at levee mile 7.91.

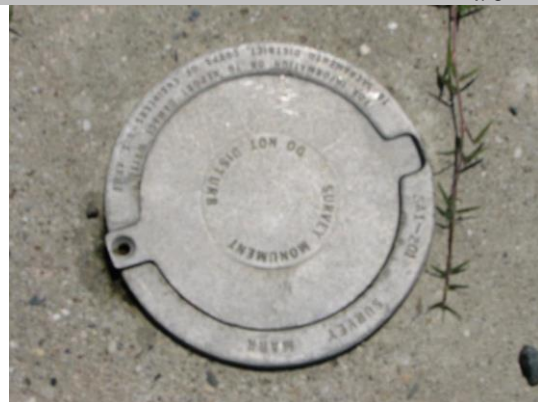
Photo 1 of 3 : UCIP_SP_2017_22306_38067.jpg

| UCIP Comments: Need to contact owner to determine status of crossing. Need date of last inspection and confirmation that crossing is still in operable condition. | | | | | |

Survey marker found at this location.
